RE: Milliken and Company – Hillside Plant
LaGrange, Troup County, Georgia
Site Inspection Report

SITE INSPECTION

**MILLIKEN & COMPANY – HILLSIDE PLANT
LAGRANGE, TROUP COUNTY, GEORGIA
GAD 981 275 993**

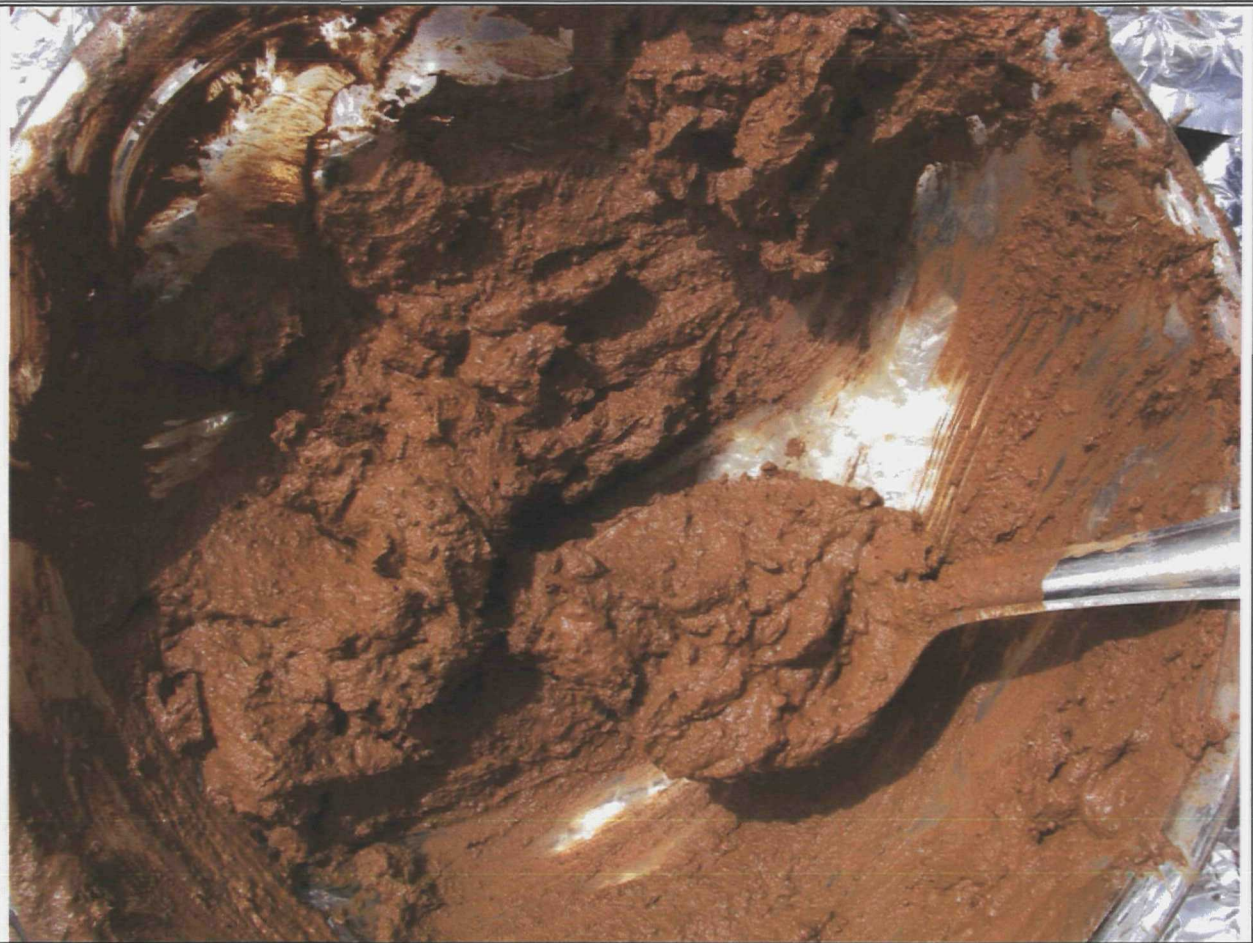
Depiction of sediment sample matrix collected from off-site Sample Station No. STA-13-SED (HW10995).

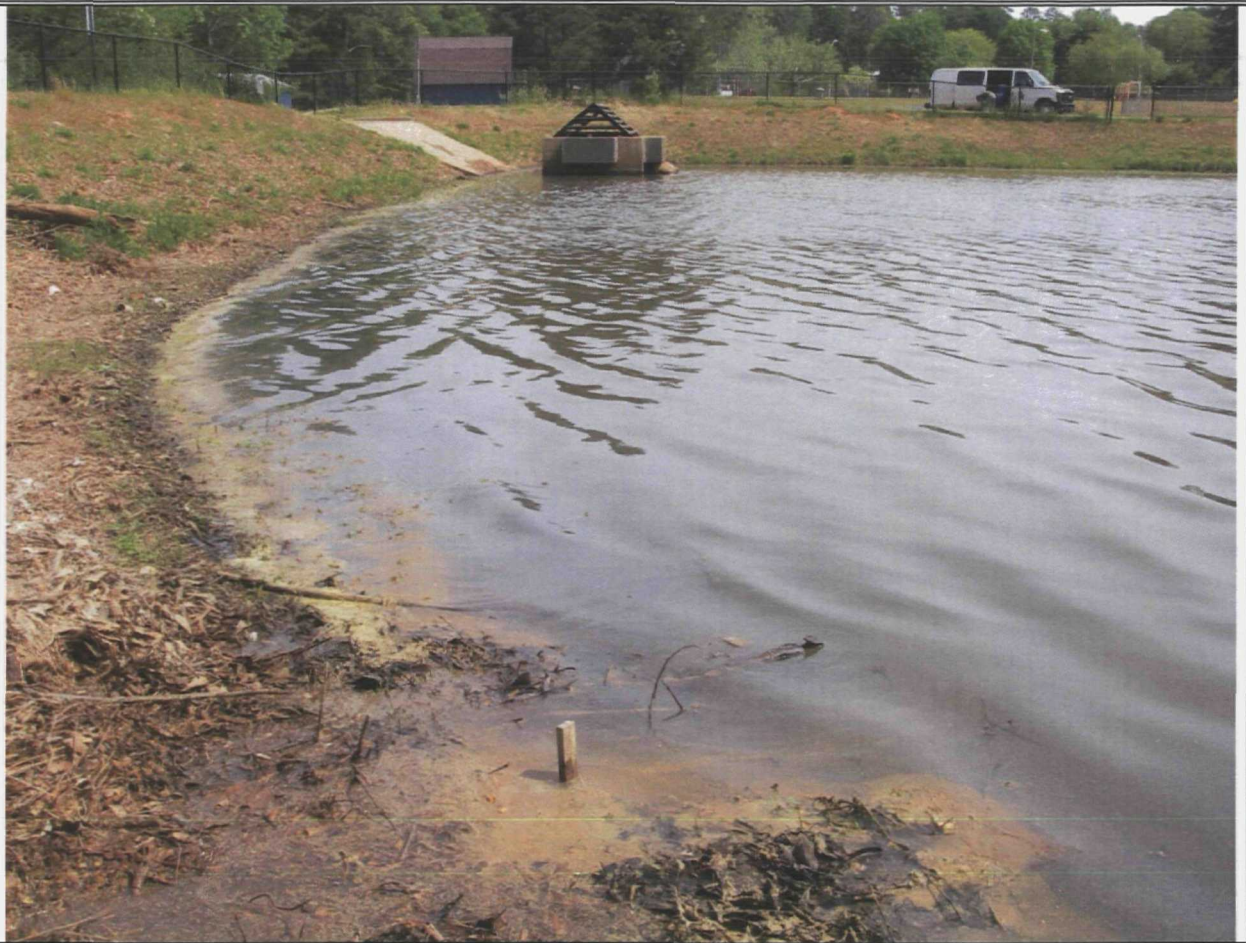
Depiction of pond at Granger Park in vicinity of where surface water and sediment samples were collected from off-site Sample Station Nos. STA-13-SW and STA-13-SED respectively (HW10994 and HW10995 respectively).

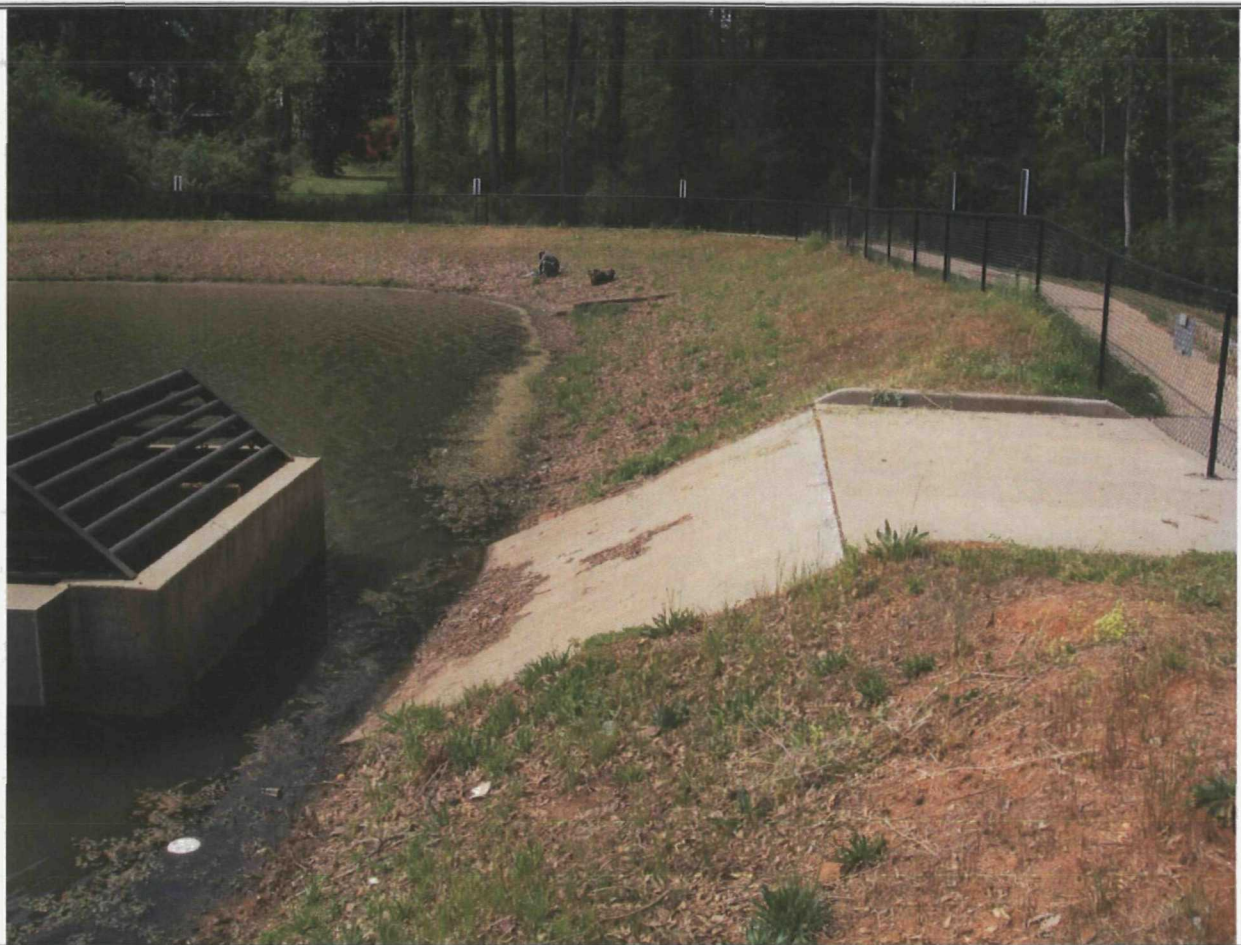
Depiction of pond at Granger Park where surface water and sediment samples were collected from off-site Sample Station Nos. STA-13-SW and STA-13-SED respectively (HW10994 and HW10995 respectively).

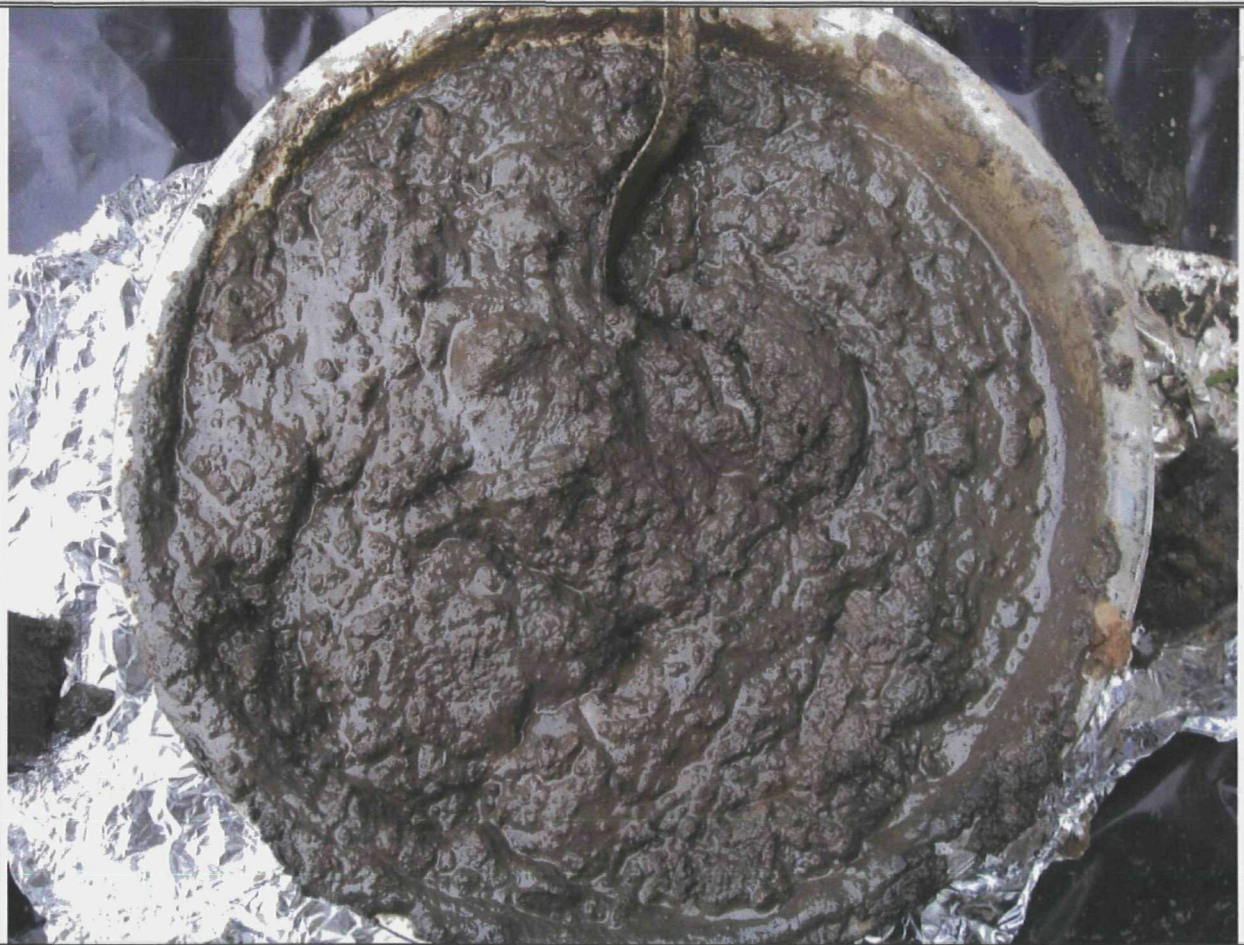
Depiction of sediment sample matrix collected from on-site Sample Station No. STA-12-SED (HW10993).

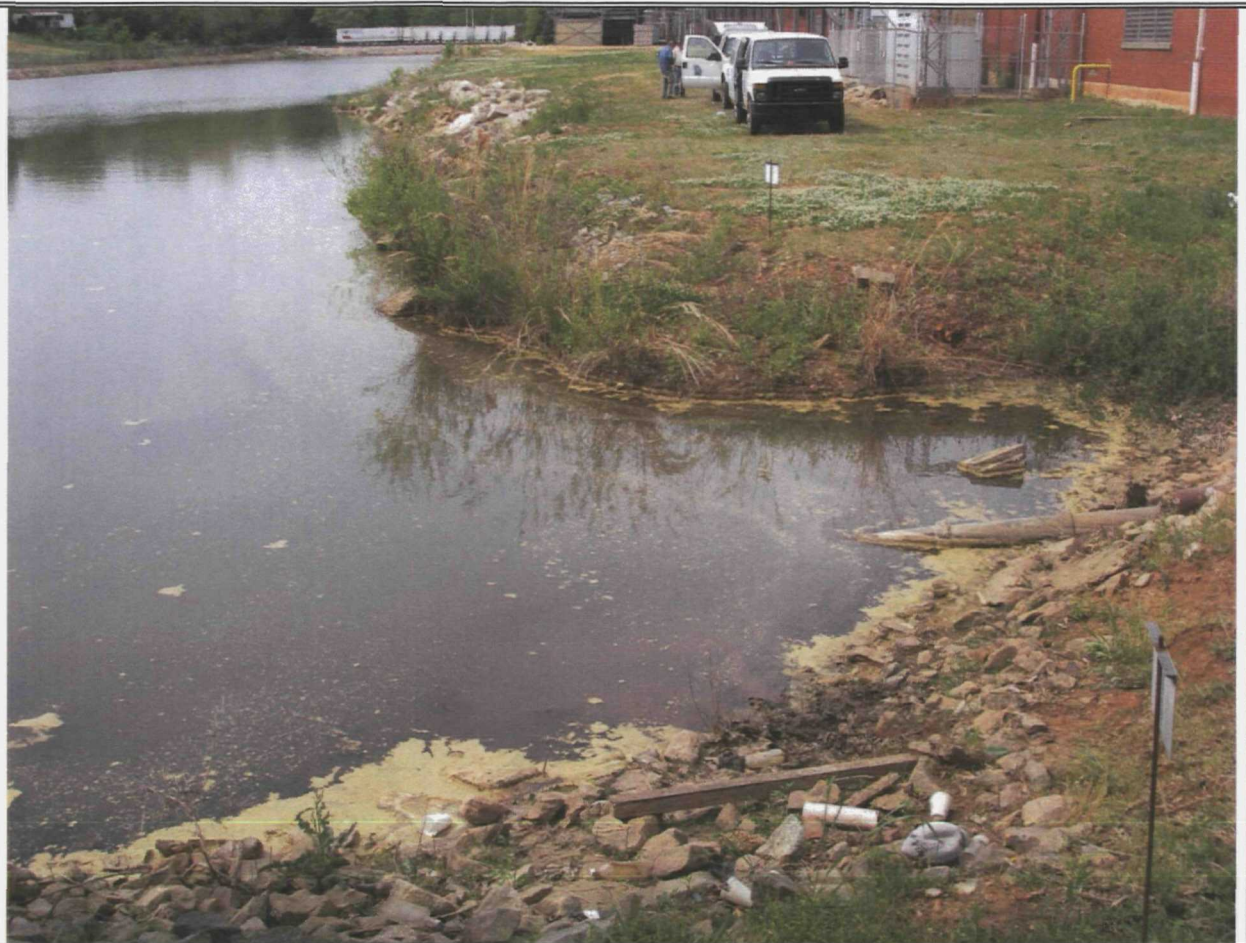
Depiction of on-site fire pond in vicinity of where surface water and sediment samples were collected from on-site Sample Station Nos. STA-12-SW and STA-12-SED respectively (HW10992 and HW10993 respectively).

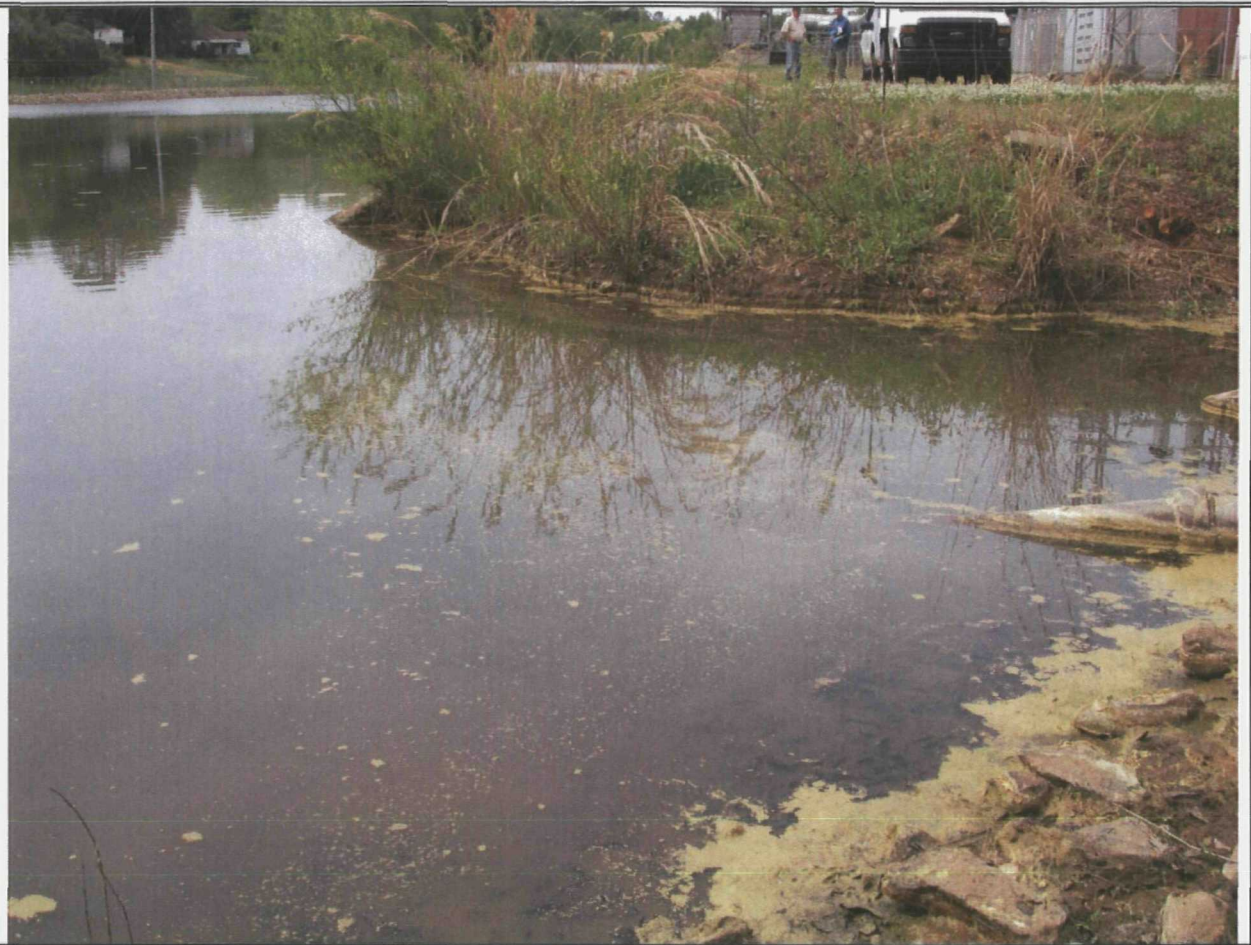
Depiction of on-site fire pond in vicinity of where surface water and sediment samples were collected from on-site Sample Station Nos. STA-12-SW and STA-12-SED respectively (HW10992 and HW10993 respectively).

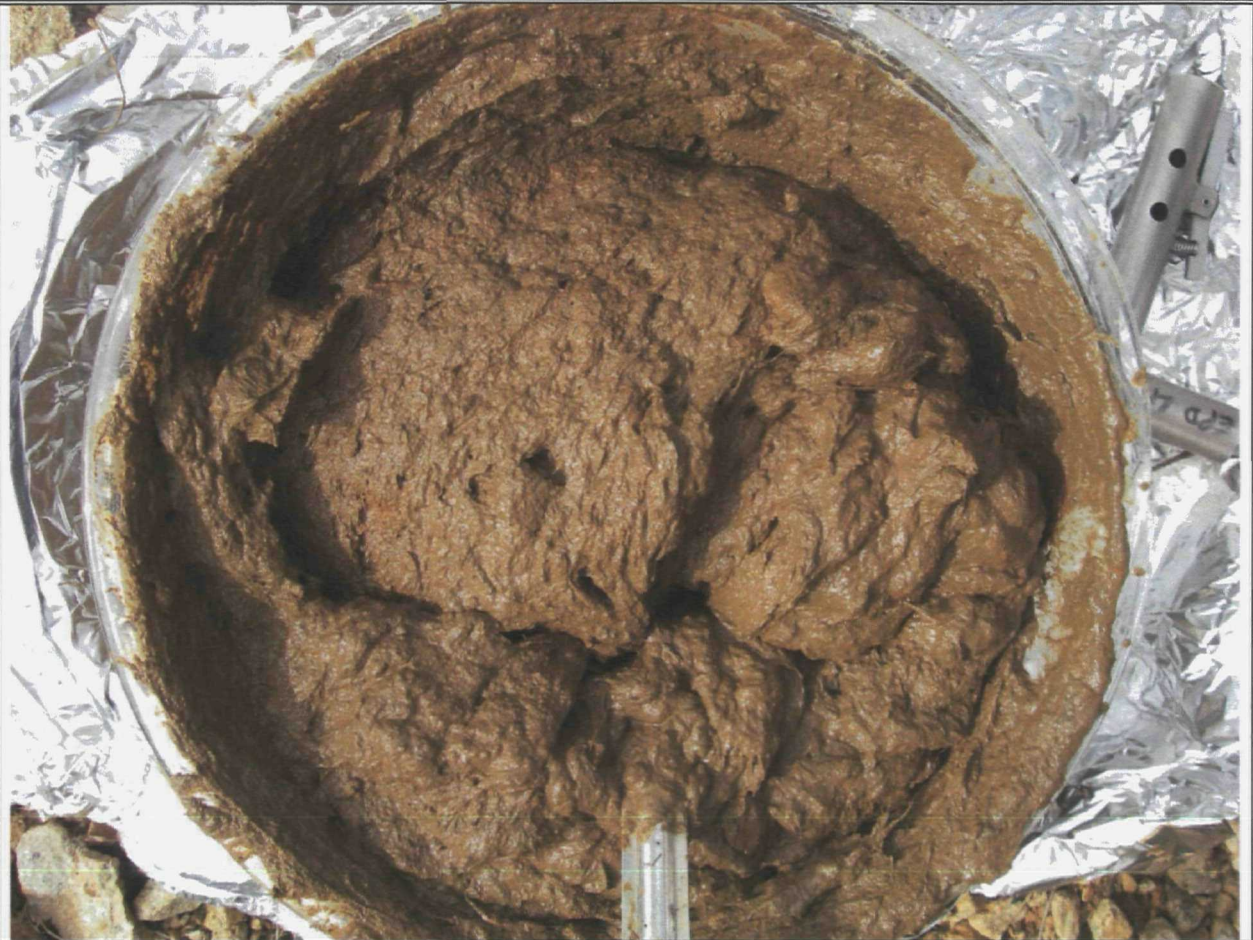
Depiction of sediment sample matrix collected from on-site Sample Station No. STA-11-SED (HW10991).

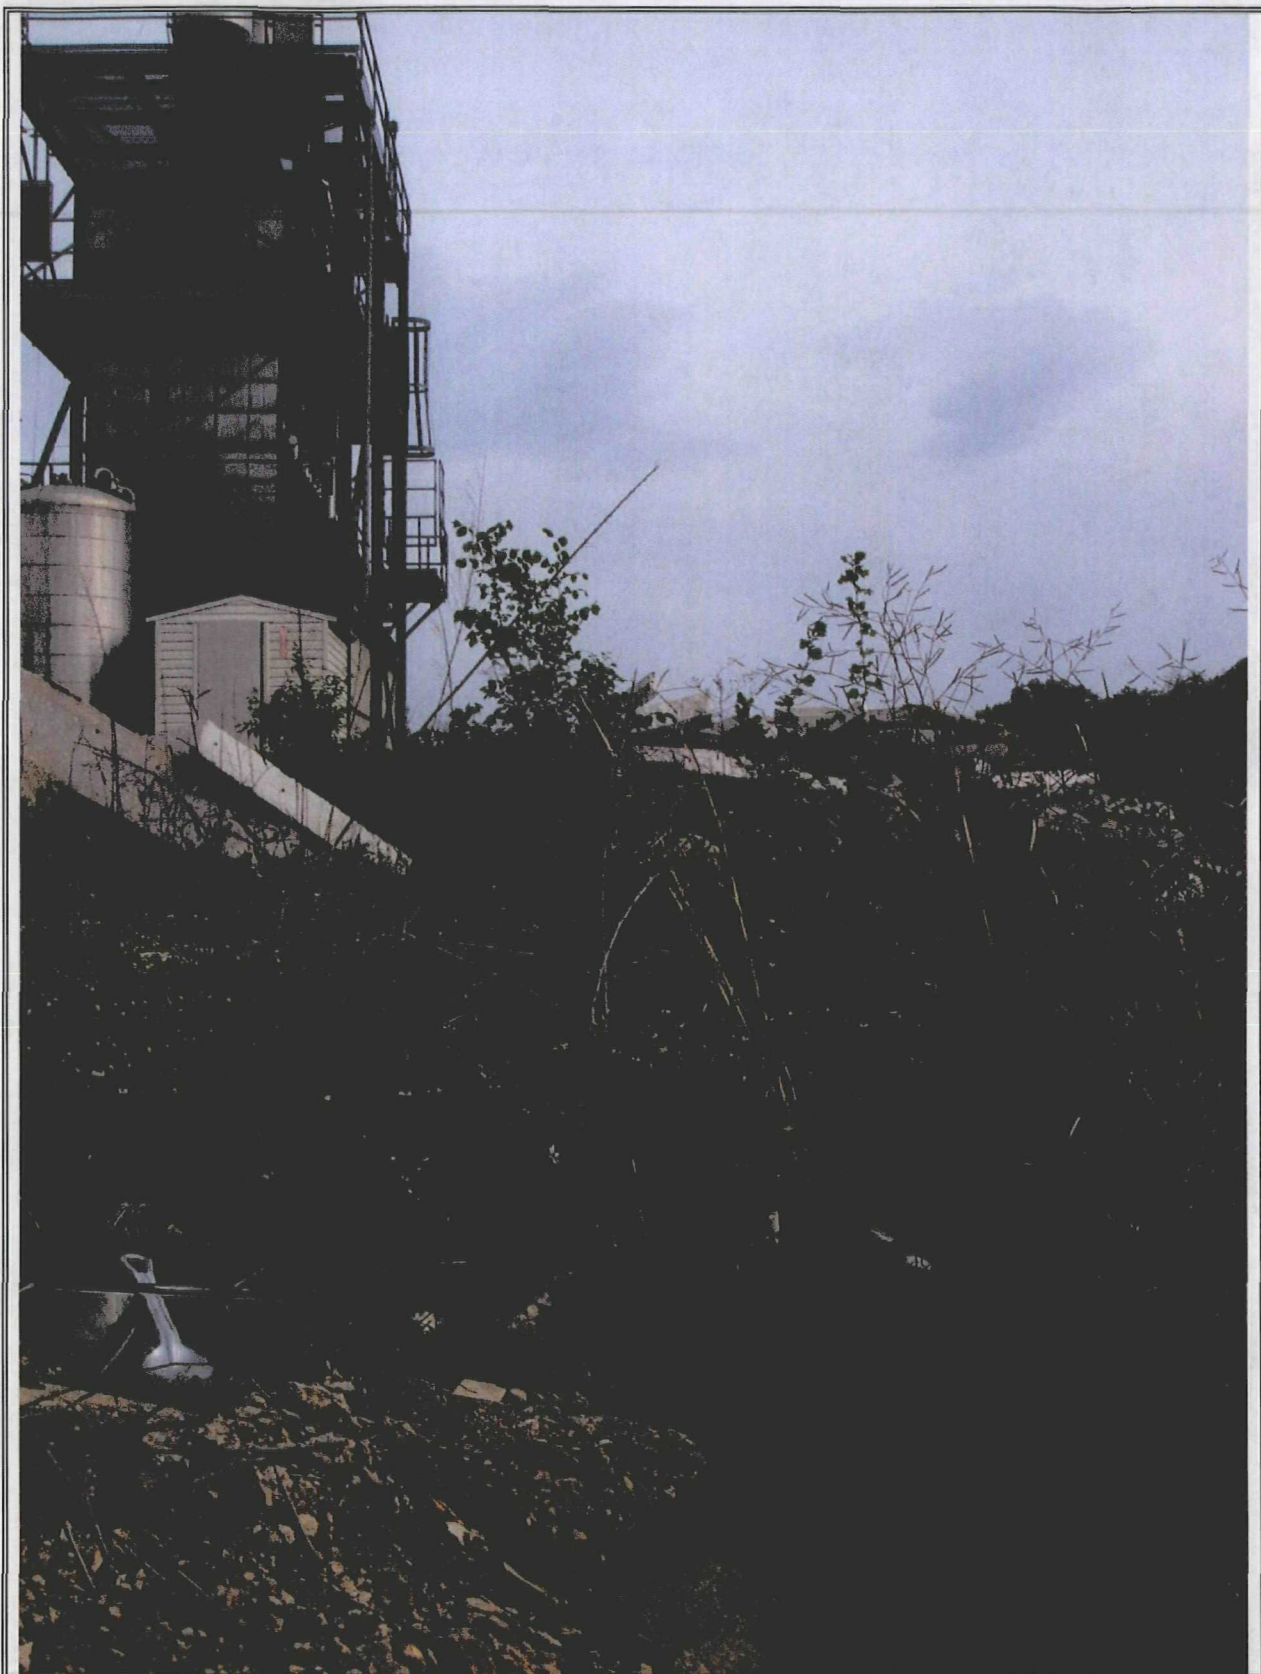
Depiction of area near on-site fire pond in vicinity of where surface water and sediment samples were collected from on-site Sample Station Nos. STA-11-SW and STA-11-SED respectively (HW10990 and HW10991 respectively).

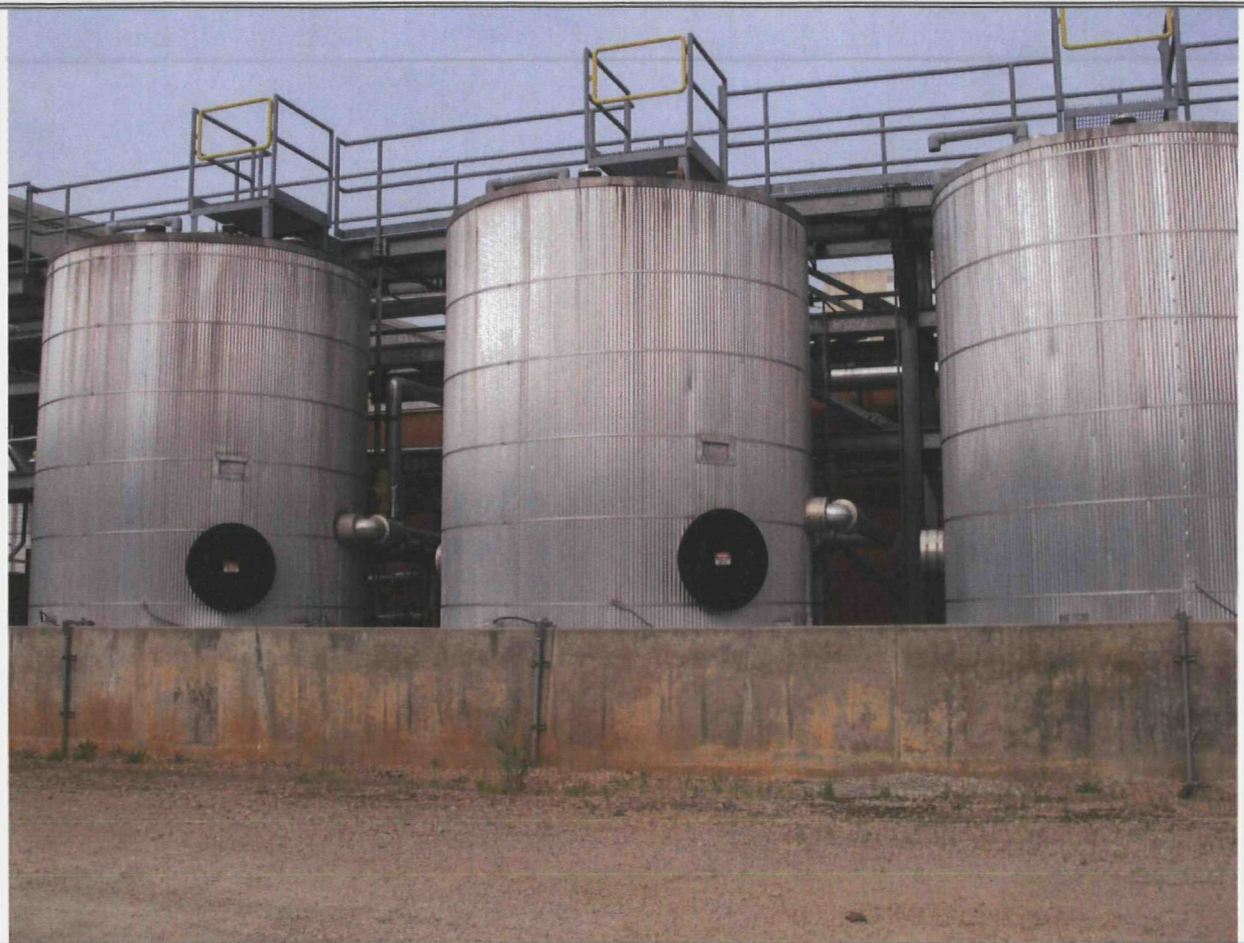
Depiction of area near on-site fire pond in vicinity of where surface water and sediment samples were collected from on-site Sample Station Nos. STA-11-SW and STA-11-SED respectively (HW10990 and HW10991 respectively).

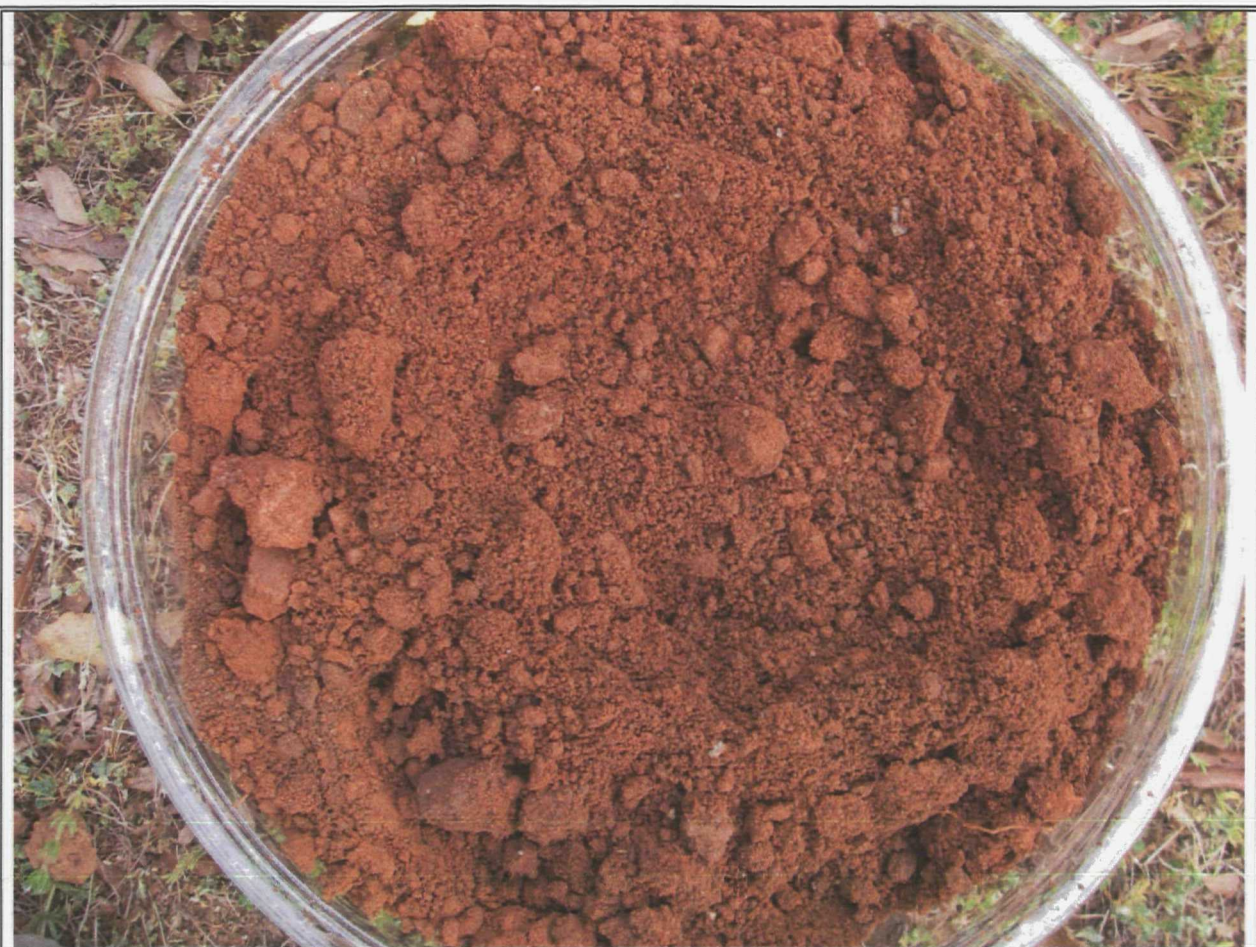
Depiction of surficial soil sample matrix collected from on-site Sample Station No. STA-18-SS (HW11001).

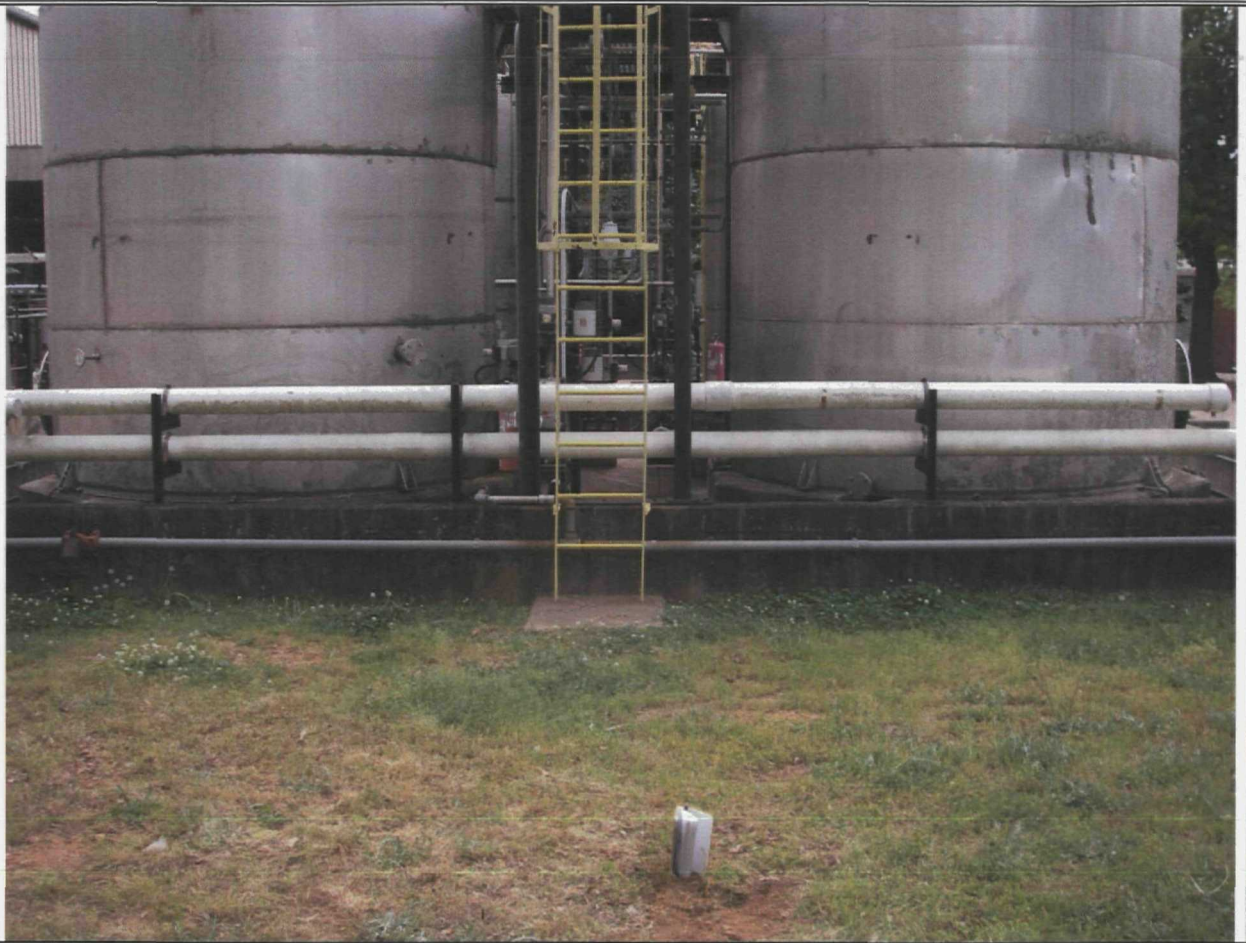
Depiction of immediate vicinity of on-site Sample Station No. STA-18-SS (HW11001).

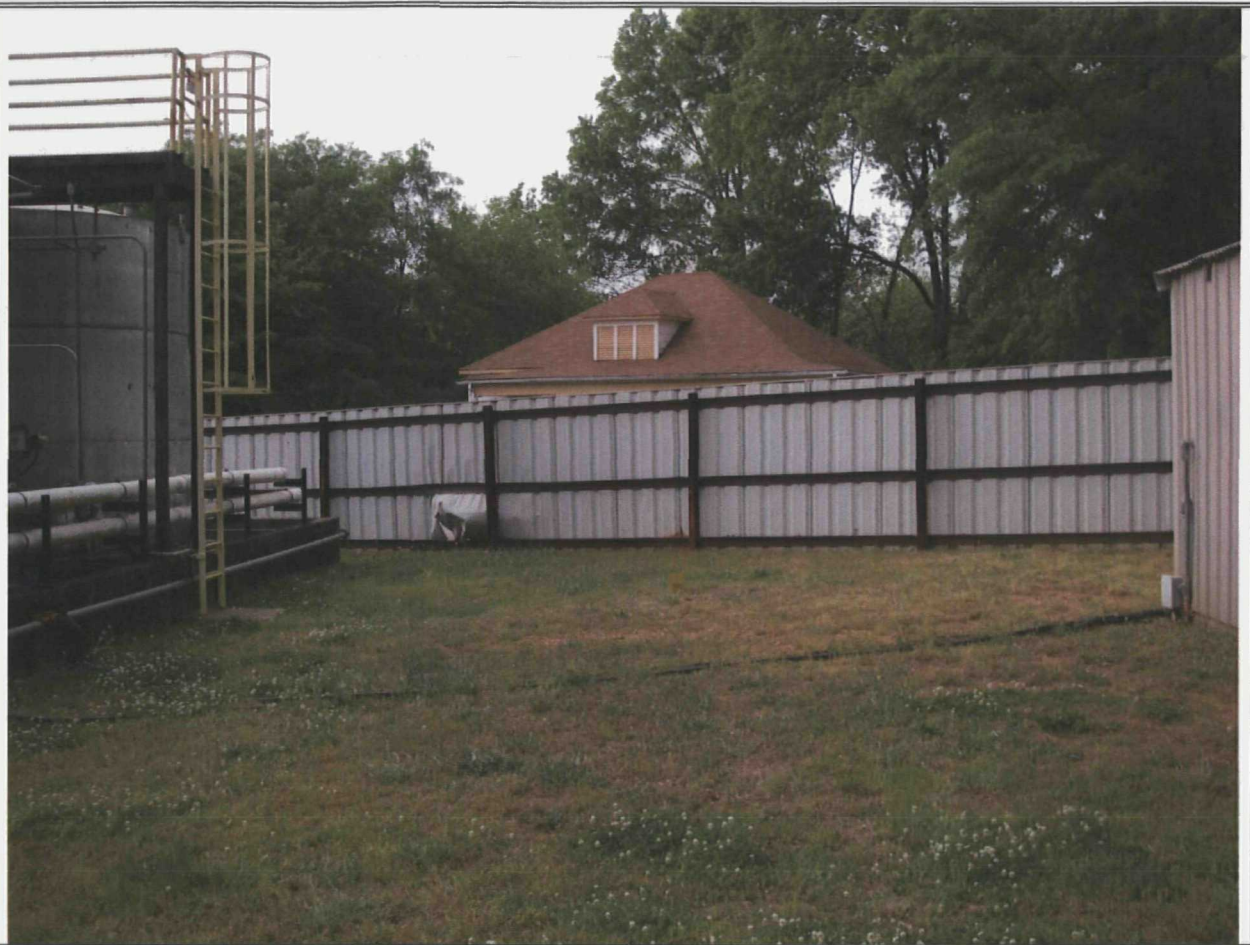
Depiction of general vicinity of on-site Sample Station No. STA-18-SS (HW11001).

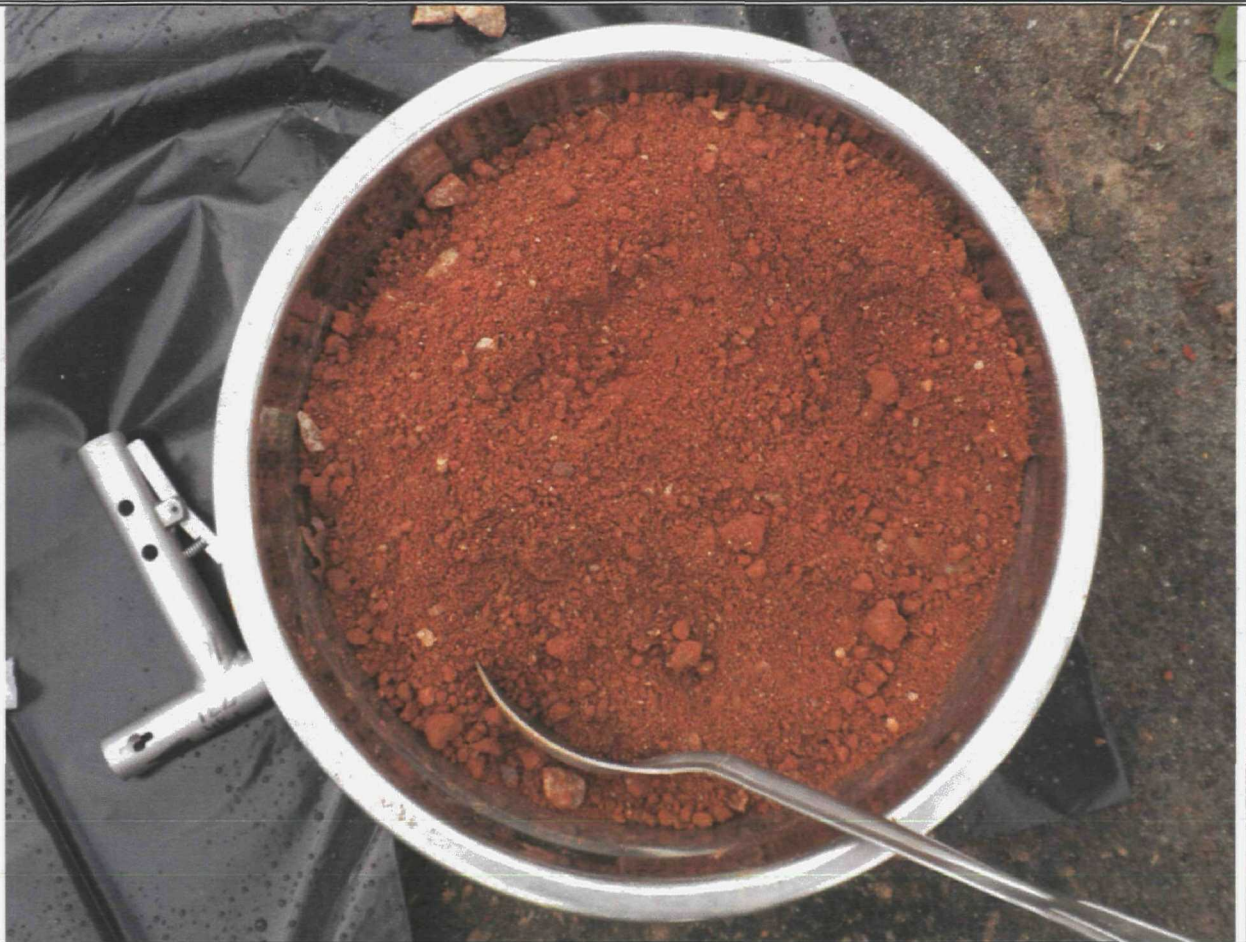
Depiction of surficial soil sample matrix collected from on-site Sample Station No. STA-26-SS (HW11010).

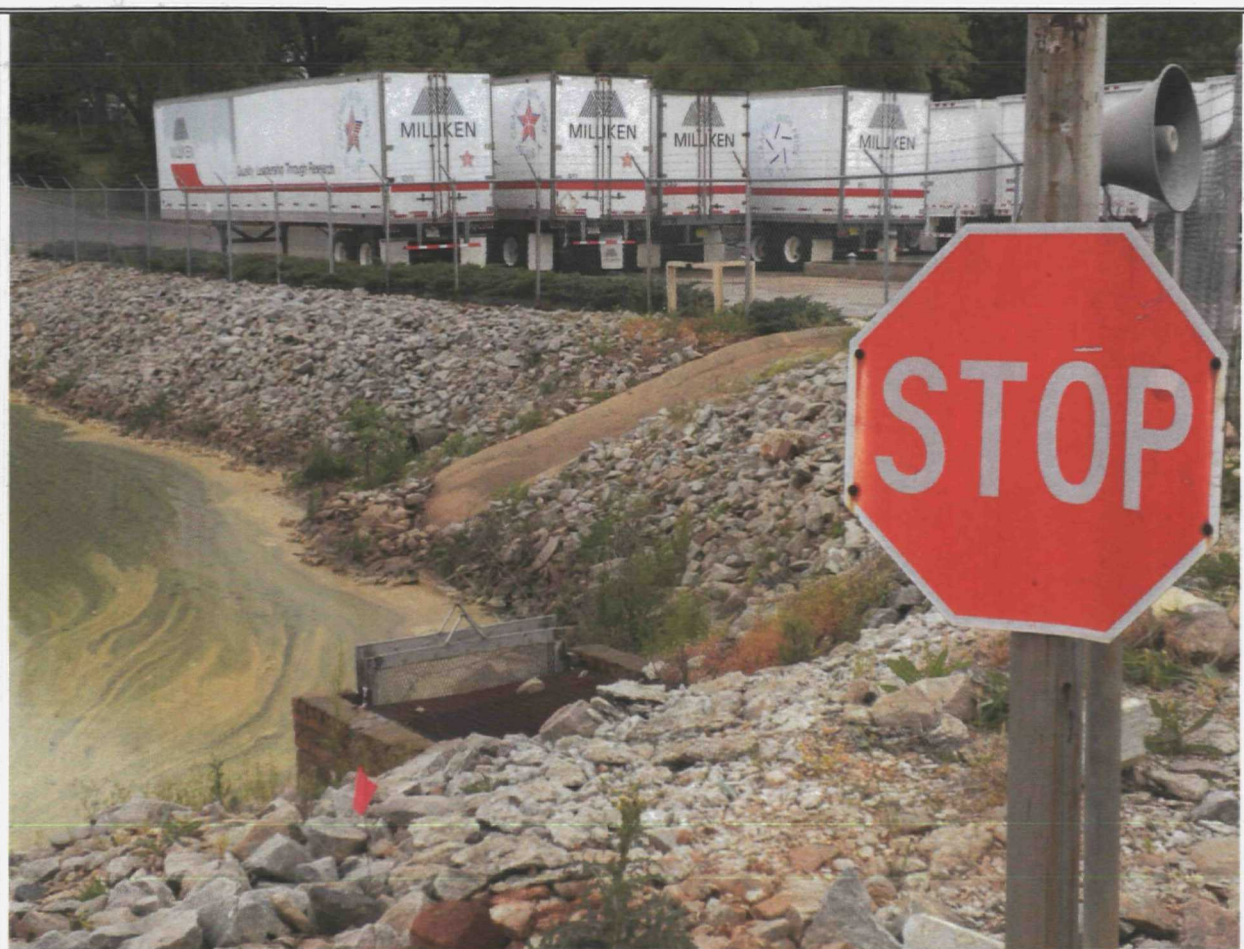
Depiction of general vicinity of on-site Sample Station No. STA-26-SS (HW11010).

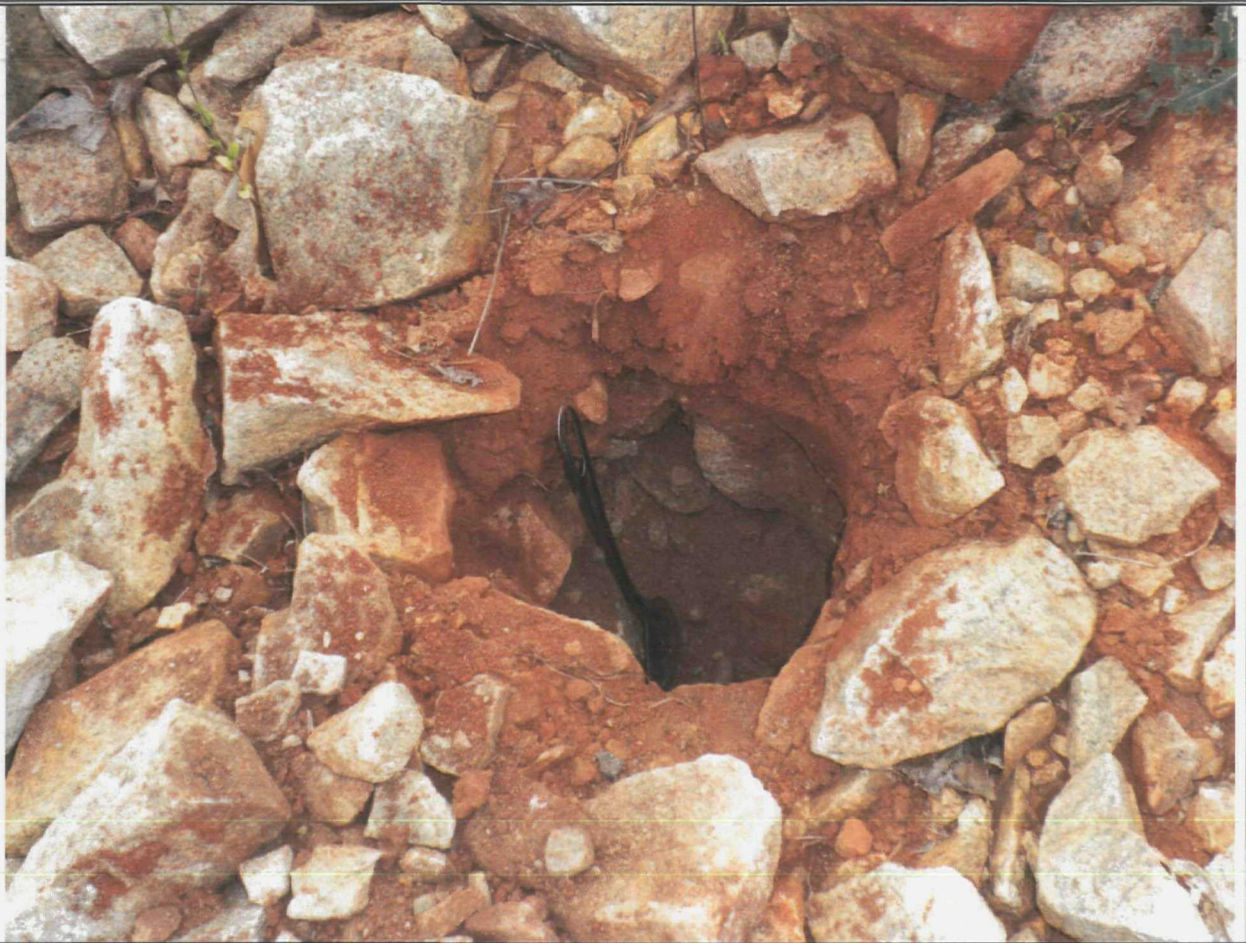
Depiction of immediate vicinity of on-site Sample Station No. STA-26-SS (HW11010).

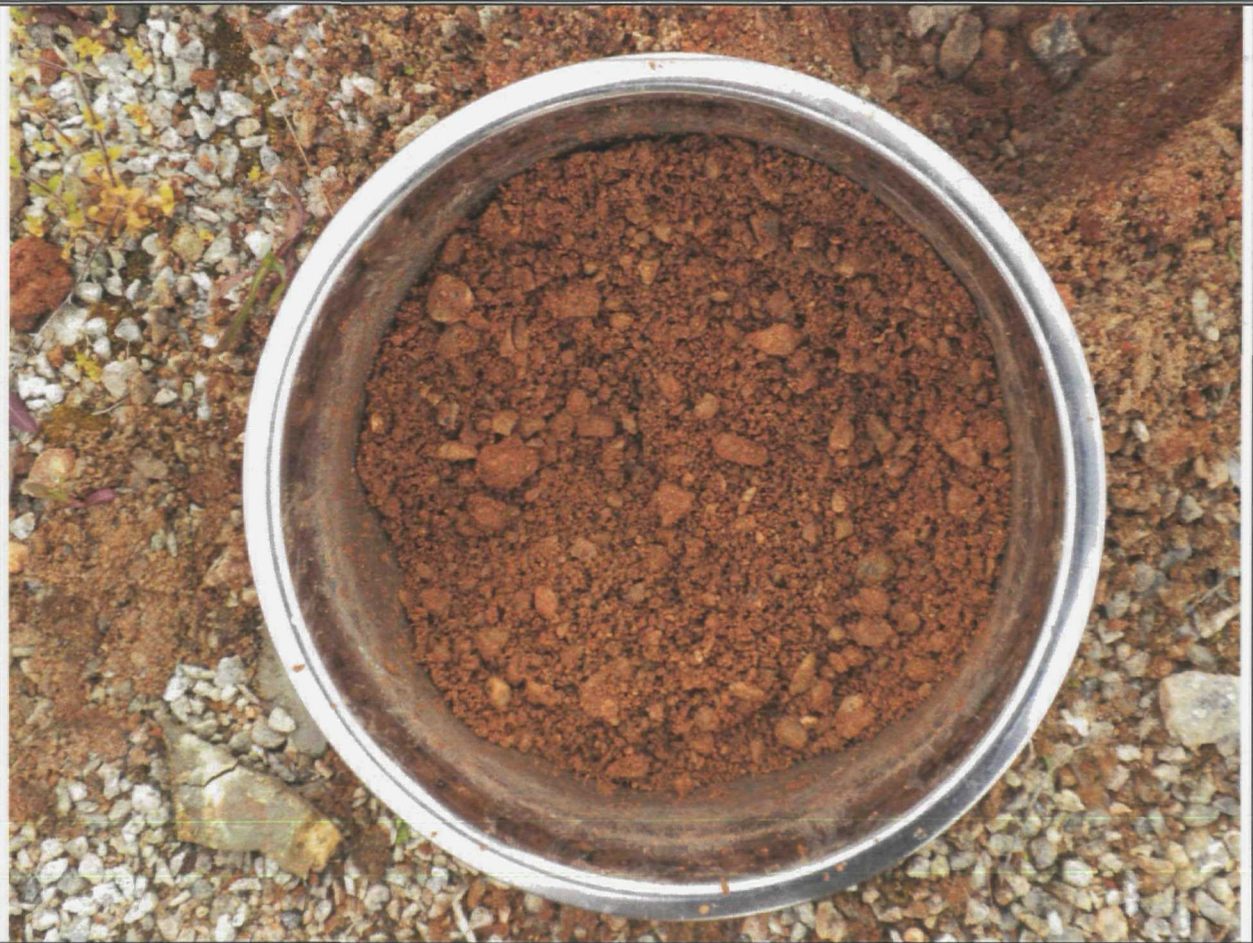
Depiction of surficial soil sample matrix collected from on-site Sample Station No. STA-29-SS (HW11011).

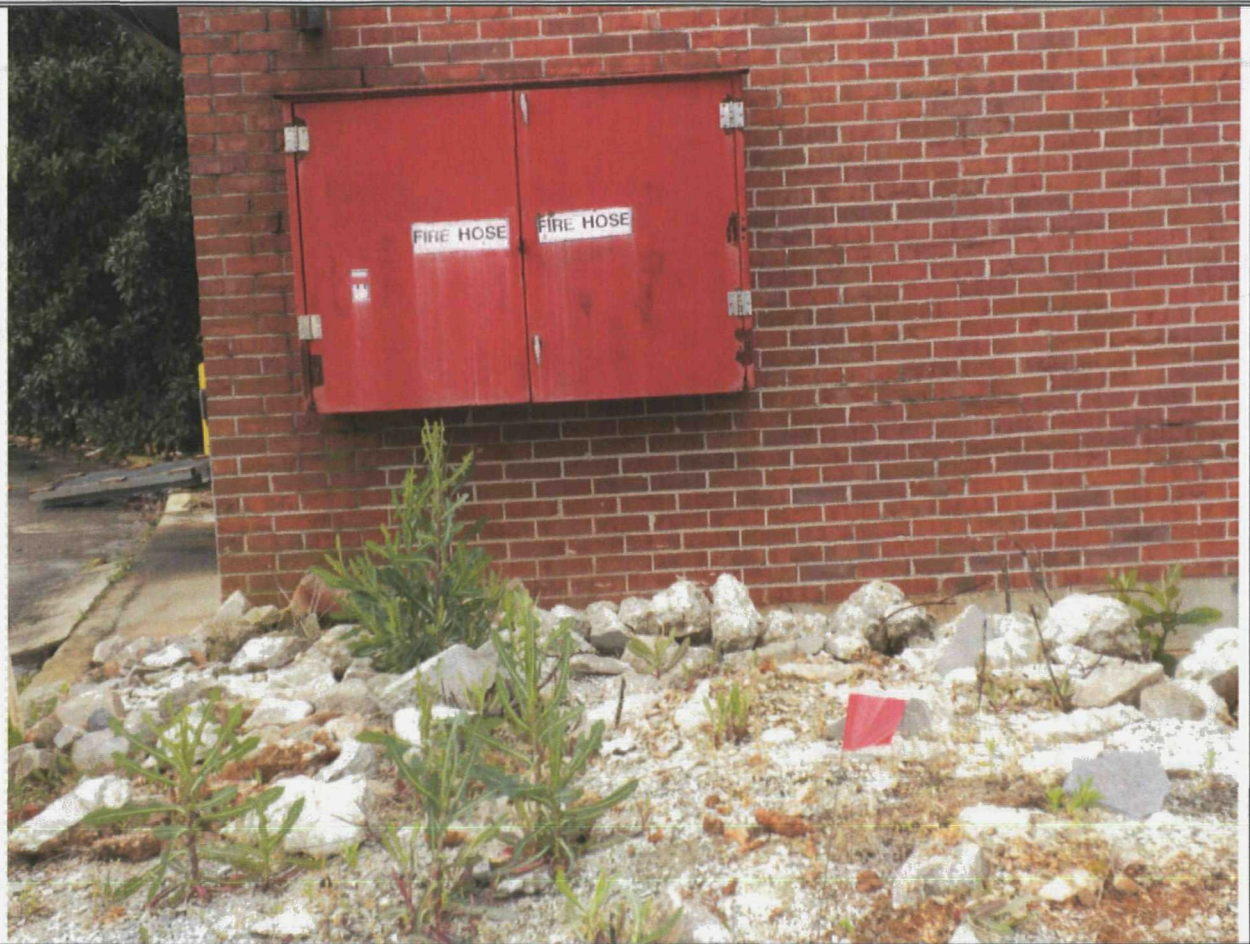
Depiction of immediate vicinity of on-site Sample Station No. STA-29-SS (HW11011).

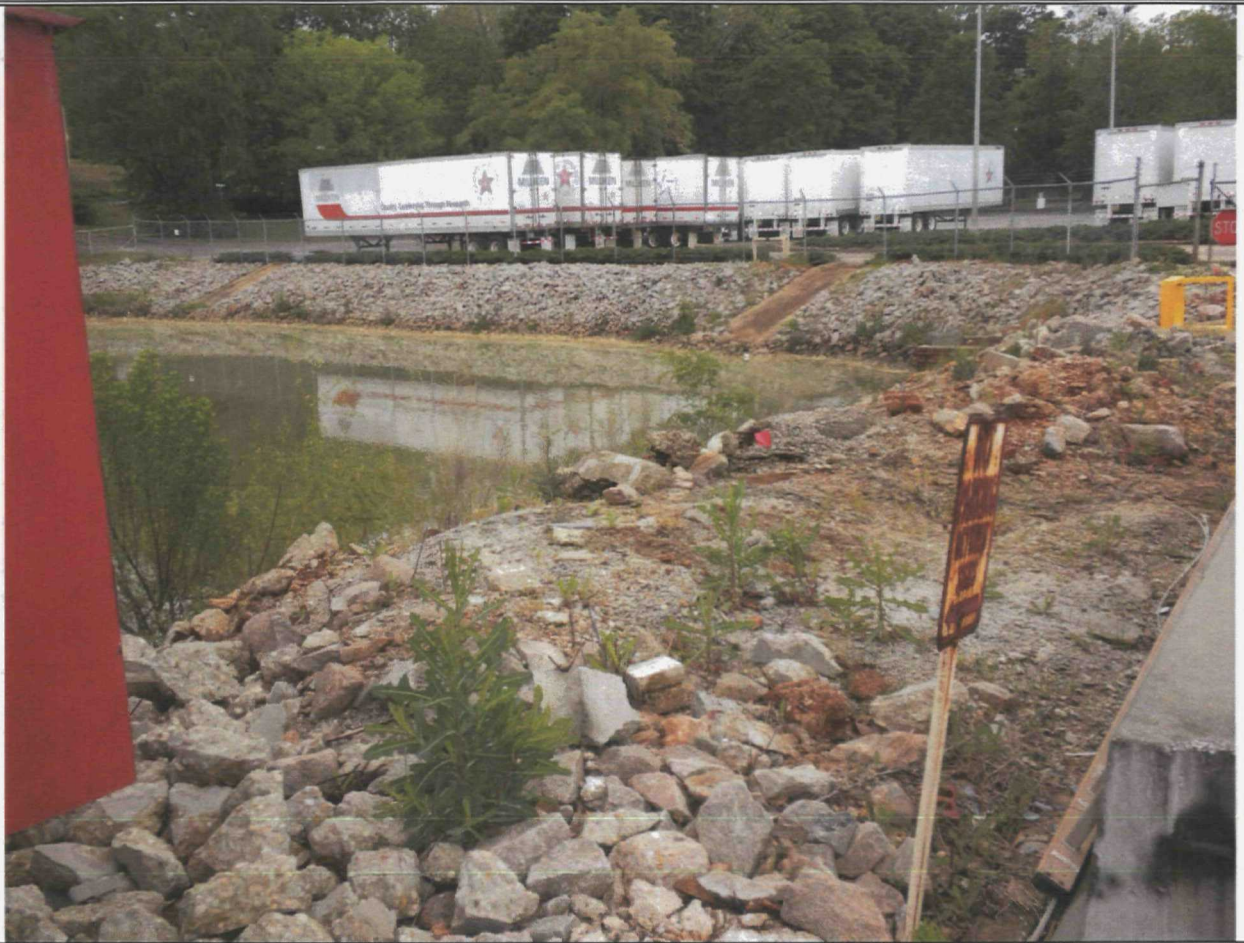
Depiction of general vicinity of on-site Sample Station No. STA-29-SS (HW11011).
